Mariposa Folk Festival and Celebration Park, Orillia

Electrical and Lighting Considerations

BRIEF REPORT

January 5, 2016

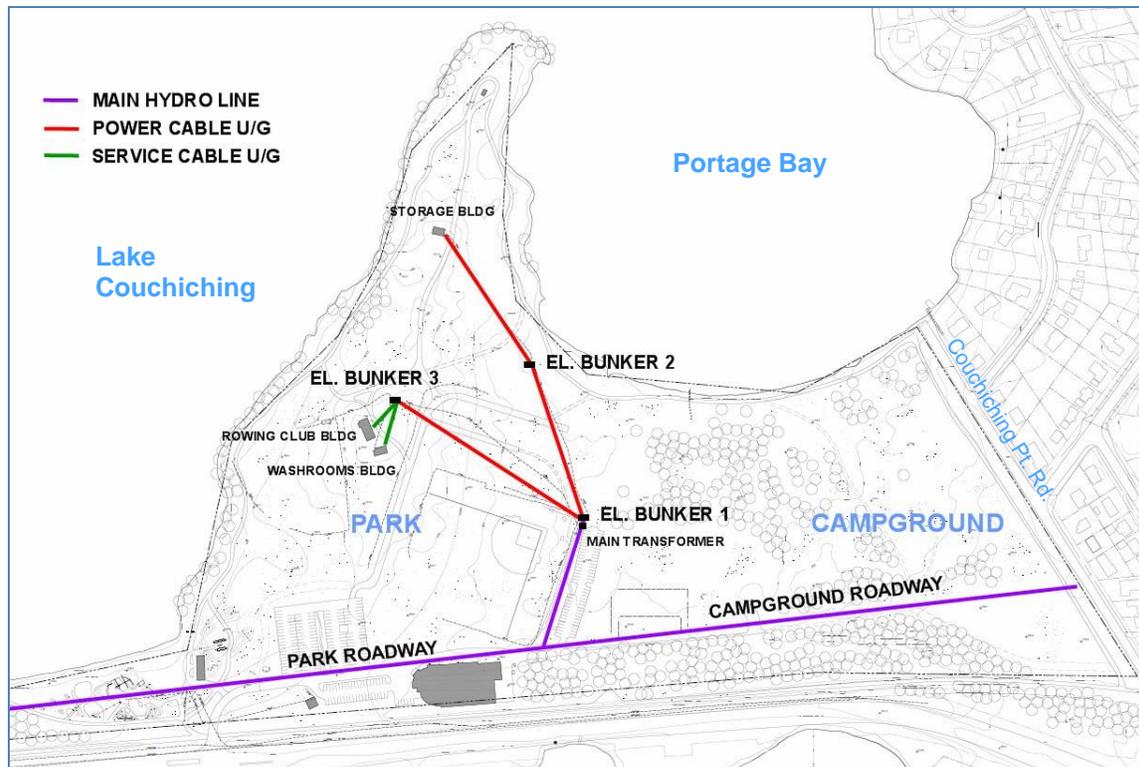
1. Present Situation - Hydro

The area is serviced by a main hydro line along south edge of the property. The Main Transformer and Electrical Bunker 1 are located centrally between the Park and the Campground. 600V power is fed by underground cables to Park hydro distribution at Bunker 2, Bunker 3 and the Park Storage Building. Presently, there is no power infrastructure at the Campground.

Bunker 2 supplies the Main Stage area except the audio equipment, which commonly comes with own mobile generators. Bunker 3 supplies the vendor area and is reportedly under-powered, with the event organizers providing extra portable generators.

While the exact extent of spare power in the system remains to be verified, the main hydro line appears adequate. If the Main Transformer and its feeder are at capacity, they may be upsized, or a second transformer added, preferably near Bunker 3 as it is centrally located to the Park.

The hydro line is owned by the Orillia Power Corporation, who needs to be approached for the records on the present hydro demand, as well as the feasibility of adding more loads.

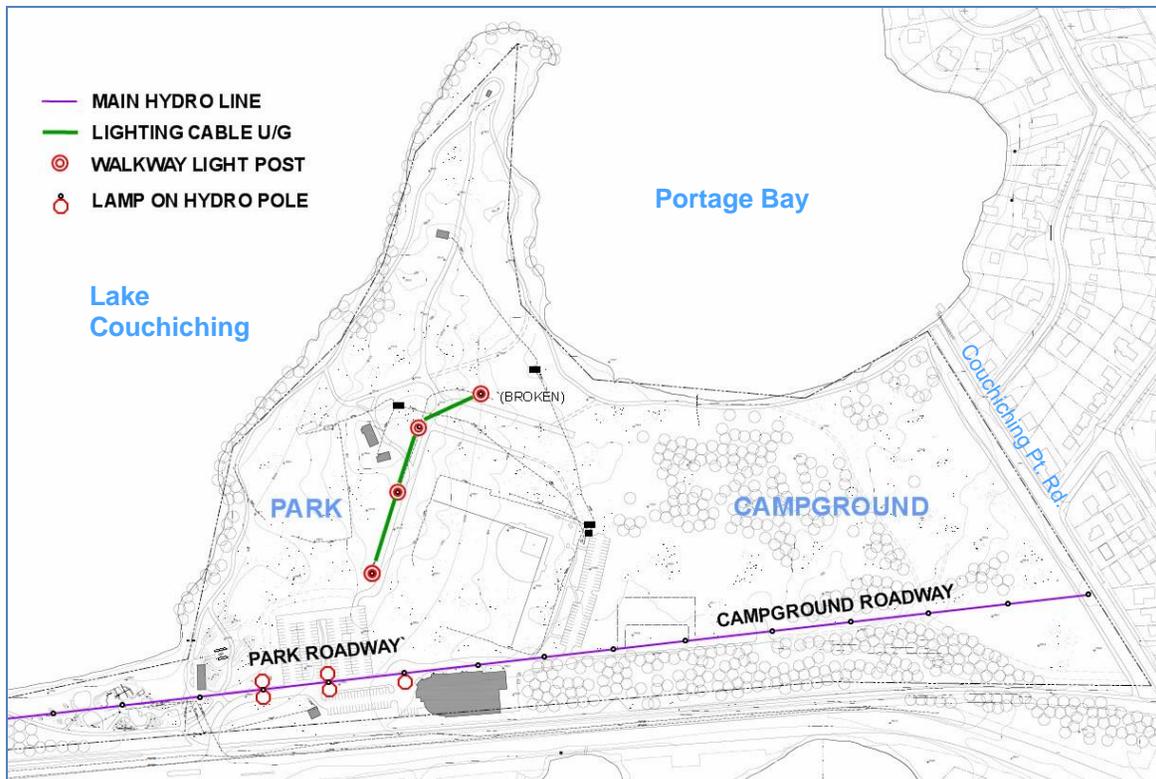
2. Present Situation - Lighting

Park lighting is in disrepair and at the barest minimum level. At the Campground there is no lighting at all, including the car parking areas and their access roads.

The Park Roadway leading from the Main Entrance to parking lots and the Campground is flanked by hydro line poles. There are cobra-head lighting fixtures on the first three and none on the rest. The Campground Roadway is totally unlit.

The Park has a network of internal pathways interconnecting the Main Entrance with parking lots and baseball fields. Its lighting consists of four light poles at the central pathway, one with a fixture missing and the other three in bad disrepair.

The Park and Campground are encircled along the waterfront by a paved pathway, known as Lightfoot Trail, connecting to the Roadway via the Couchiching Point. Road. Presently there is no illumination at either one.

There are two parking lots near the central baseball fields. Although both fields are equipped with tall-mast lighting, illumination of the parking lots is inadequate. The third overflow/ festival parking lot is located at the Campground and without any illumination.

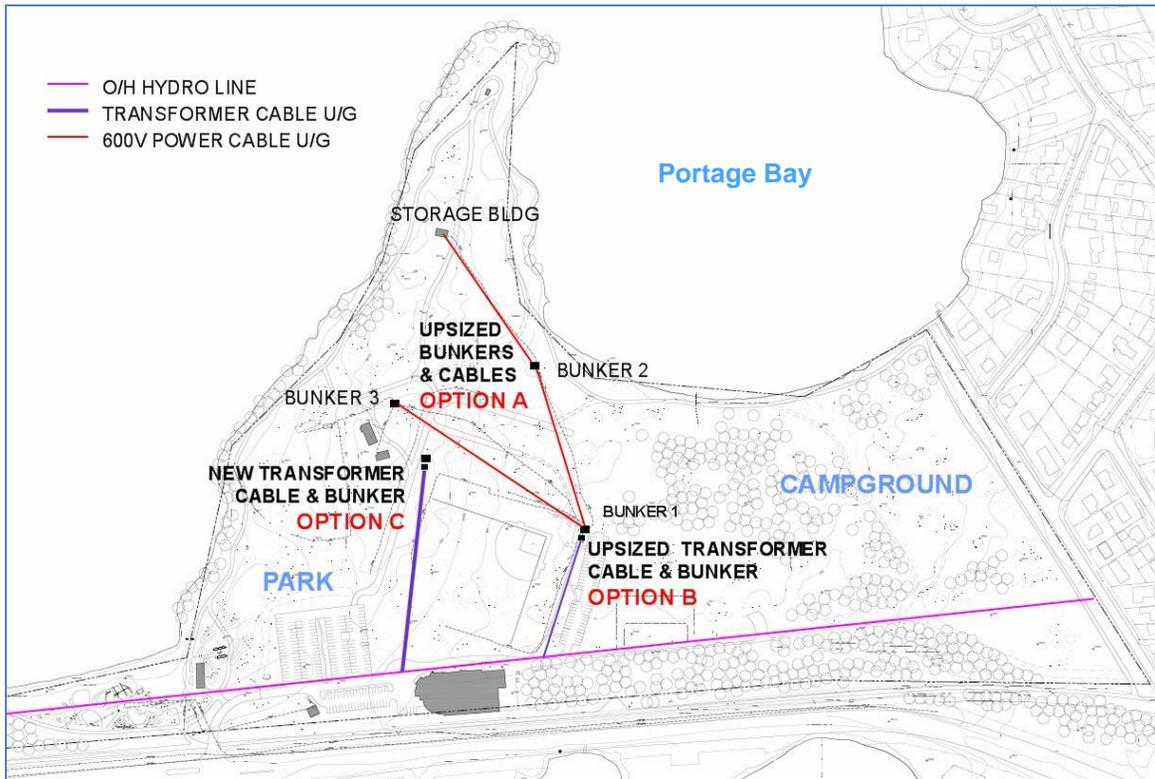
3. Hydro Power Upgrade - Options

The Bunkers and the Storage Building serve as hubs for the Park 600V power. They step the power down to 120V for distribution via underground service cables. Should the supply of hydro power prove inadequate for the Mariposa Folk Festival, it may be upgraded in either, or combination of the following options:

Replace electrical equipment inside Bunker 2, Bunker 3 and Storage Building with switches and circuit breaker panels of larger size and replace or double up existing underground cables. This will deliver more power to those distribution hubs. However, total power available to the site will remain at 300 KW, the present size of the Main Transformer.

Replace 300 KW transformer with 500 KW and upsize Bunker 1. The present transformer cable and pole equipment may need replacing as well. This option will require prior approval of the Orillia Power Corporation.

Install another 300 KW transformer centrally to the planned Festival activities. Install new bunker, transformer cable and pole equipment. This option also will require prior approval of the Orillia Power Corporation.

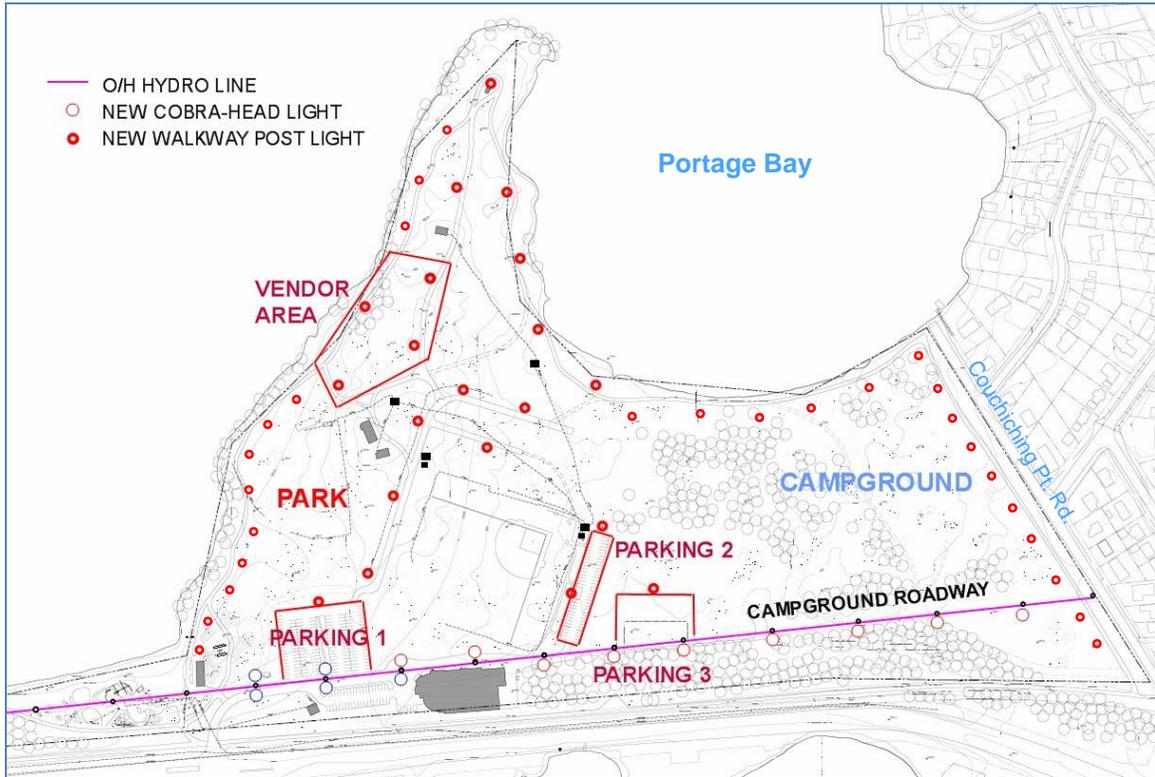
4. Lighting Upgrade Concept

Lighting at the parking lots fails to meet the required municipal and provincial levels. It is recommended that proper parking lot illumination is considered for each of the lots.

The hydro line along the Park and Campground Roadway can provide an economical way of illuminating the vehicular traffic. The existing hydro poles may be used for new lighting fixtures.

The Park Roadway should be lit using photocells. As the Campground has only seasonal use, its cobra-heads may be placed on a master switch and turned off when not necessary.

Existing light poles at the Park central walkway are in disrepair, pose a liability and should be all replaced. It is also recommended to logically extend the present lighting by adding new poles.

As during the Festival vendor booths are set up and remain for several nights, it is recommended to add lighting poles in the Vendor Area.

It is recommended to install lighting along the entire lake-front Lightfoot Trail. In addition, based on the available budget, lighting along the Couchiching Point Road should also be considered, to connect Lightfoot Trail with the Roadway.

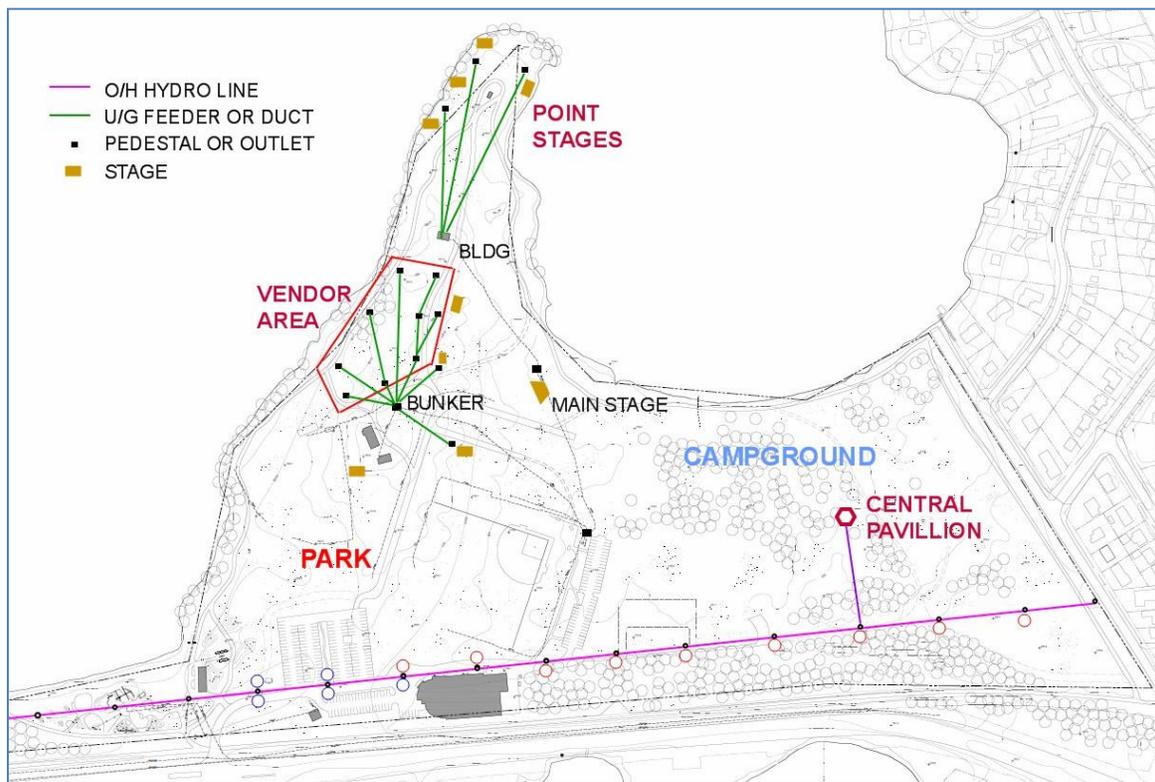
5. Further Considerations

During Mariposa Festival, event organizers provide temporary portable generators, to which vendors plug in their extension cords.

To avoid stringing cords overland, safe passage under pathways may be created using buried PVC ducts. Alternatively, a permanent solution may be provided by low-profile pedestals with GFI safety receptacles, similar to those the City of Barrie uses at the annual KempenFest Waterfront Festival.

Also, the Campground could benefit from a seasonal building with potable water supply, power hub and charging station for smart phones and personal devices.
