116 & 120 BOND STREET, ORILLIA, ON

LANDMARK ENVIRONMENTAL GROUP LTD.

PROJECT NO. LA 834-23 & LA 1010-25

- EX-1: 116 BOND STREET-EXISTING CONDITIONS
- EX-2: 120 BOND STREET-EXISTING CONDITIONS
- TP-1: 116 BOND STREET-TREE PRESERVATION PLAN 1
- TP-2: 116 BOND STREET-TREE PRESERVATION PLAN 2
- TP-3: 120 BOND STREET-TREE PRESERVATION PLAN 3
- TP-4: 120 BOND STREET-TREE PRESERVATION PLAN 4
- L-1: 116 & 120 BOND STREET-OVERALL LANDSCAPE PLAN
- L-2: 116 BOND STREET-LANDSCAPE PLAN
- L-3: 120 BOND STREET-LANDSCAPE PLAN
- LD-1: DETAILS 1
- LD-2: DETAILS 2
- LD-3: DETAILS 3

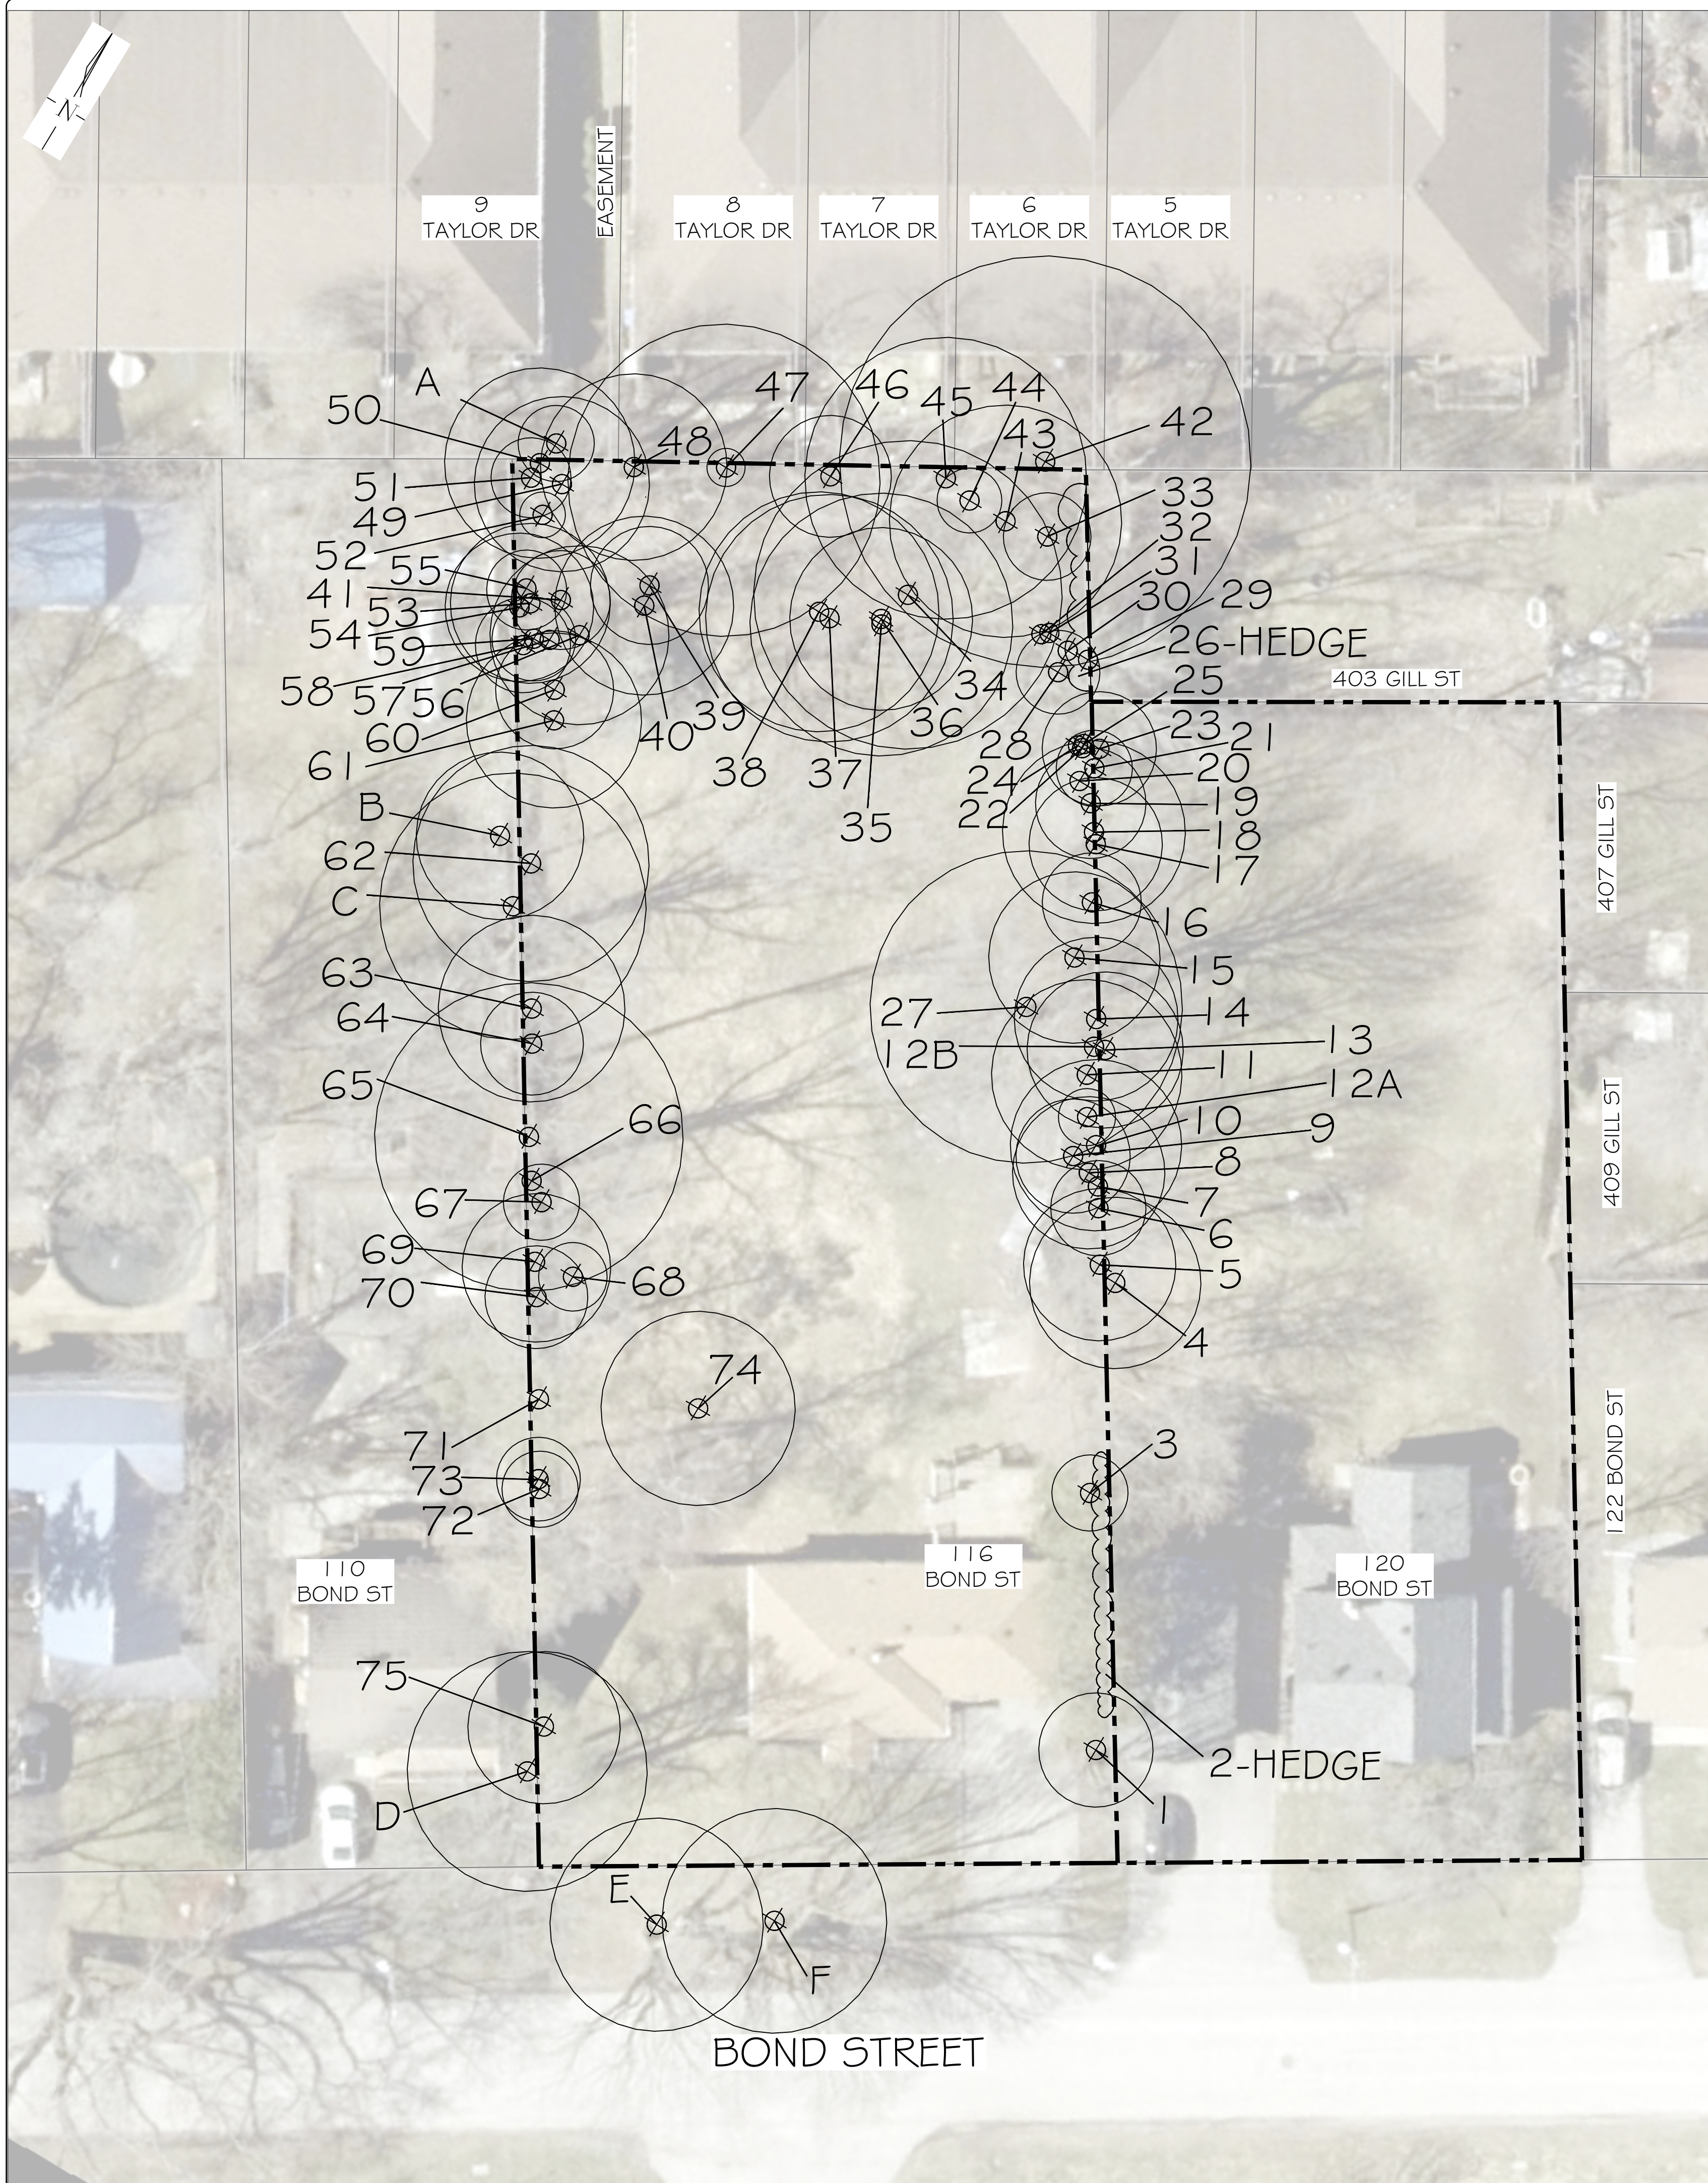
DRAWING: 116 BOND STREET- EXISTING CONDITIONS

TREE INVENTORY (116 Bond Street)									
Key	Location	Latin Name	Common Name	DBH (cm)	Comments	Assessment	Canopy	Preserve/Remove	
1	Onsite Tree	<i>Juglans nigra</i>	Black Walnut	29, 29.5, 32.5	Epicormic branching, pruned multiple leaders included bark, 1 stem cut	3 Fair	3.0	Remove	
2	HEDGE	<i>Thuja occidentalis</i>	Eastern White Cedar	15-25	Multiple stems, branch dieback, snow load damage	2 Marginal	2.0	Remove	
3	Onsite Tree	<i>Fraxinus pennsylvanica</i>	Green Ash	16.5	Offset canopy, epicormic branching, crooked trunk	1 Poor	2.0	Remove	
4	Onsite Tree	<i>Acer negundo</i>	Manitoba Maple	26.5, 32, 30, 14	Multiple trunks included bark, epicormic branching, decay at base	1 Poor	4.5	Remove	
5	Onsite Tree	<i>Acer negundo</i>	Manitoba Maple	17, 27	Fruiting bodies, lean, epicormic branching, included bark	1 Poor	4.0	Remove	
6	Onsite Tree	<i>Juglans nigra</i>	Black Walnut	26	One sided branching to east, creeper vine, branch dieback	2 Marginal	2.5	Remove

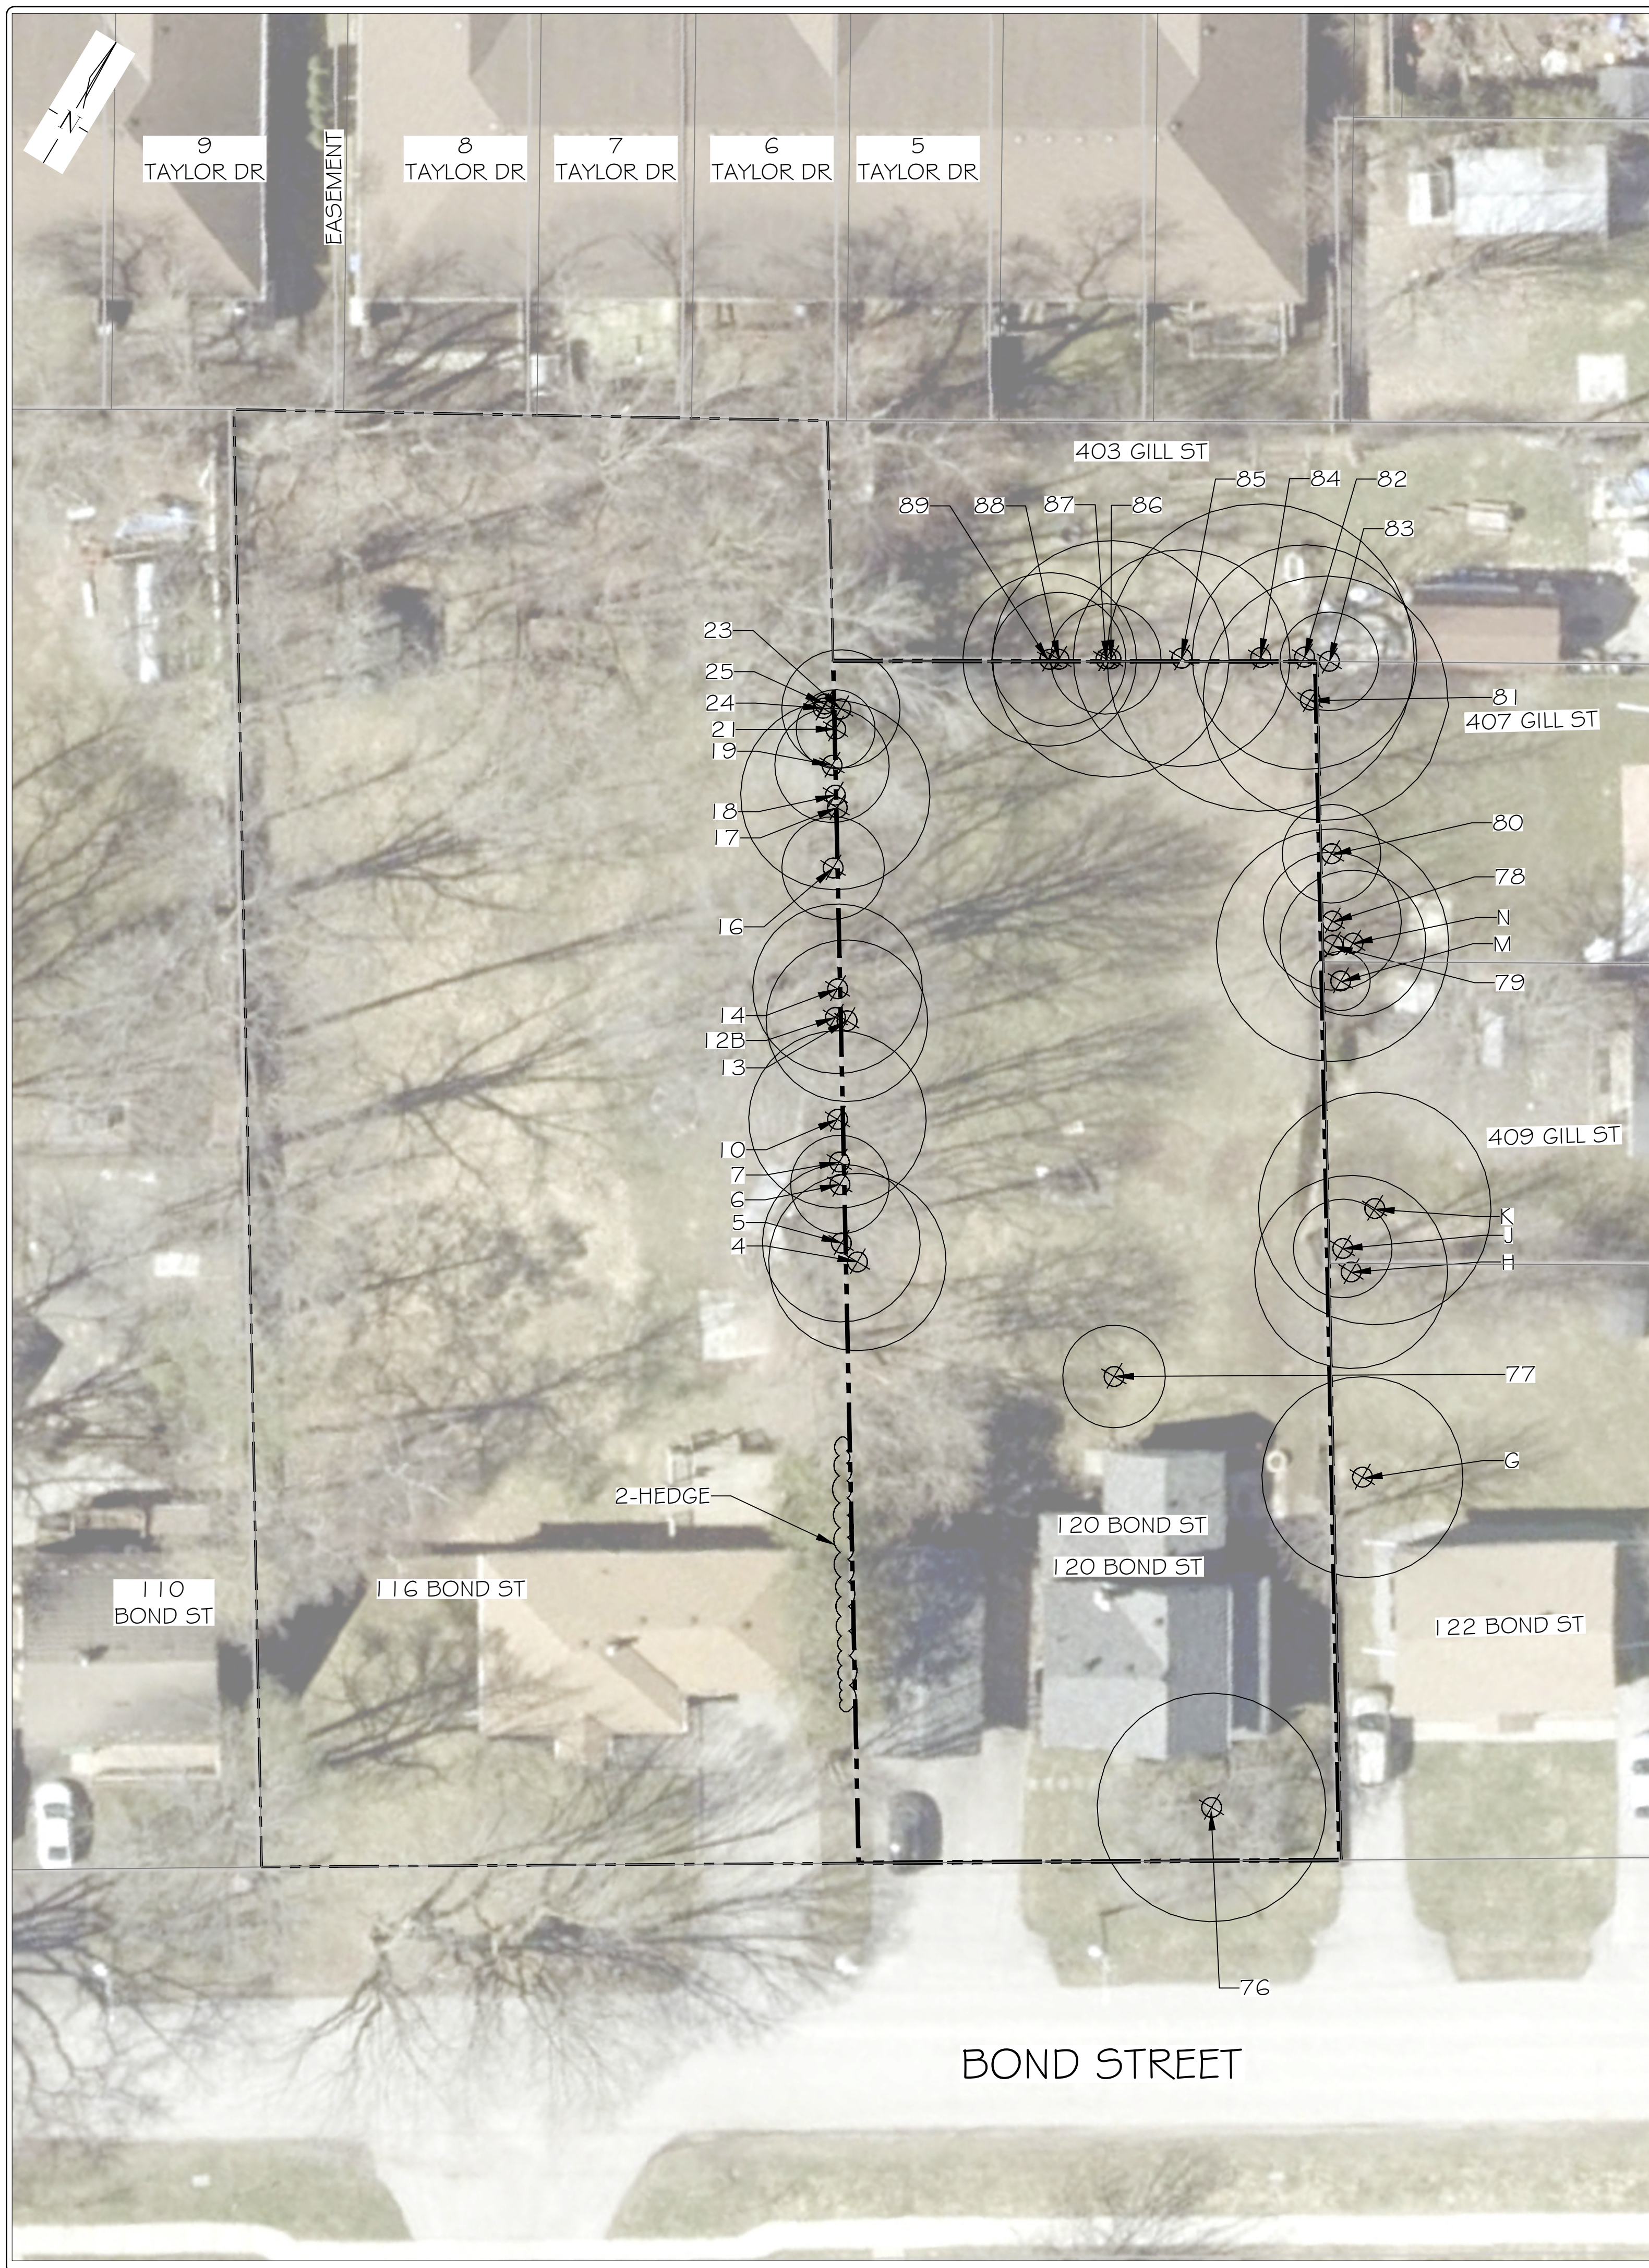
DRAWING: 120 BOND STREET- EXISTING CONDITIONS

TREE INVENTORY (116 Bond Street & 120 Bond Street)									
Key	Location	Latin Name	Common Name	DBH (cm)	Comments	Assessment	Canopy	Preserve/Remove	
2	HEDGE	<i>Thuja occidentalis</i>	Eastern White Cedar	15-25	Multiple stems, branch dieback, snow load damage	2 Marginal	2.0	Remove	
4	Onsite Tree	<i>Acer negundo</i>	Manitoba Maple	26.5, 32, 30, 14	Multiple trunks included bark, epicormic branching, decay at base	1 Poor	4.5	Remove	
5	Onsite Tree	<i>Acer negundo</i>	Manitoba Maple	17, 27	Fruiting bodies, lean, epicormic branching, included bark	1 Poor	4.0	Remove	
6	Onsite Tree	<i>Juglans nigra</i>	Black Walnut	26	One sided branching to west, root flare swell	2 Marginal	2.5	Remove	
7	Onsite Tree	<i>Fraxinus pennsylvanica</i>	Green Ash	12		0 Dead	0.0	Remove	
10	Onsite Tree	<i>Juglans nigra</i>	Black Walnut	21, 25.7	Multiple leaders included bark, one sided branching, creeper vine	2 Marginal	4.5	Remove

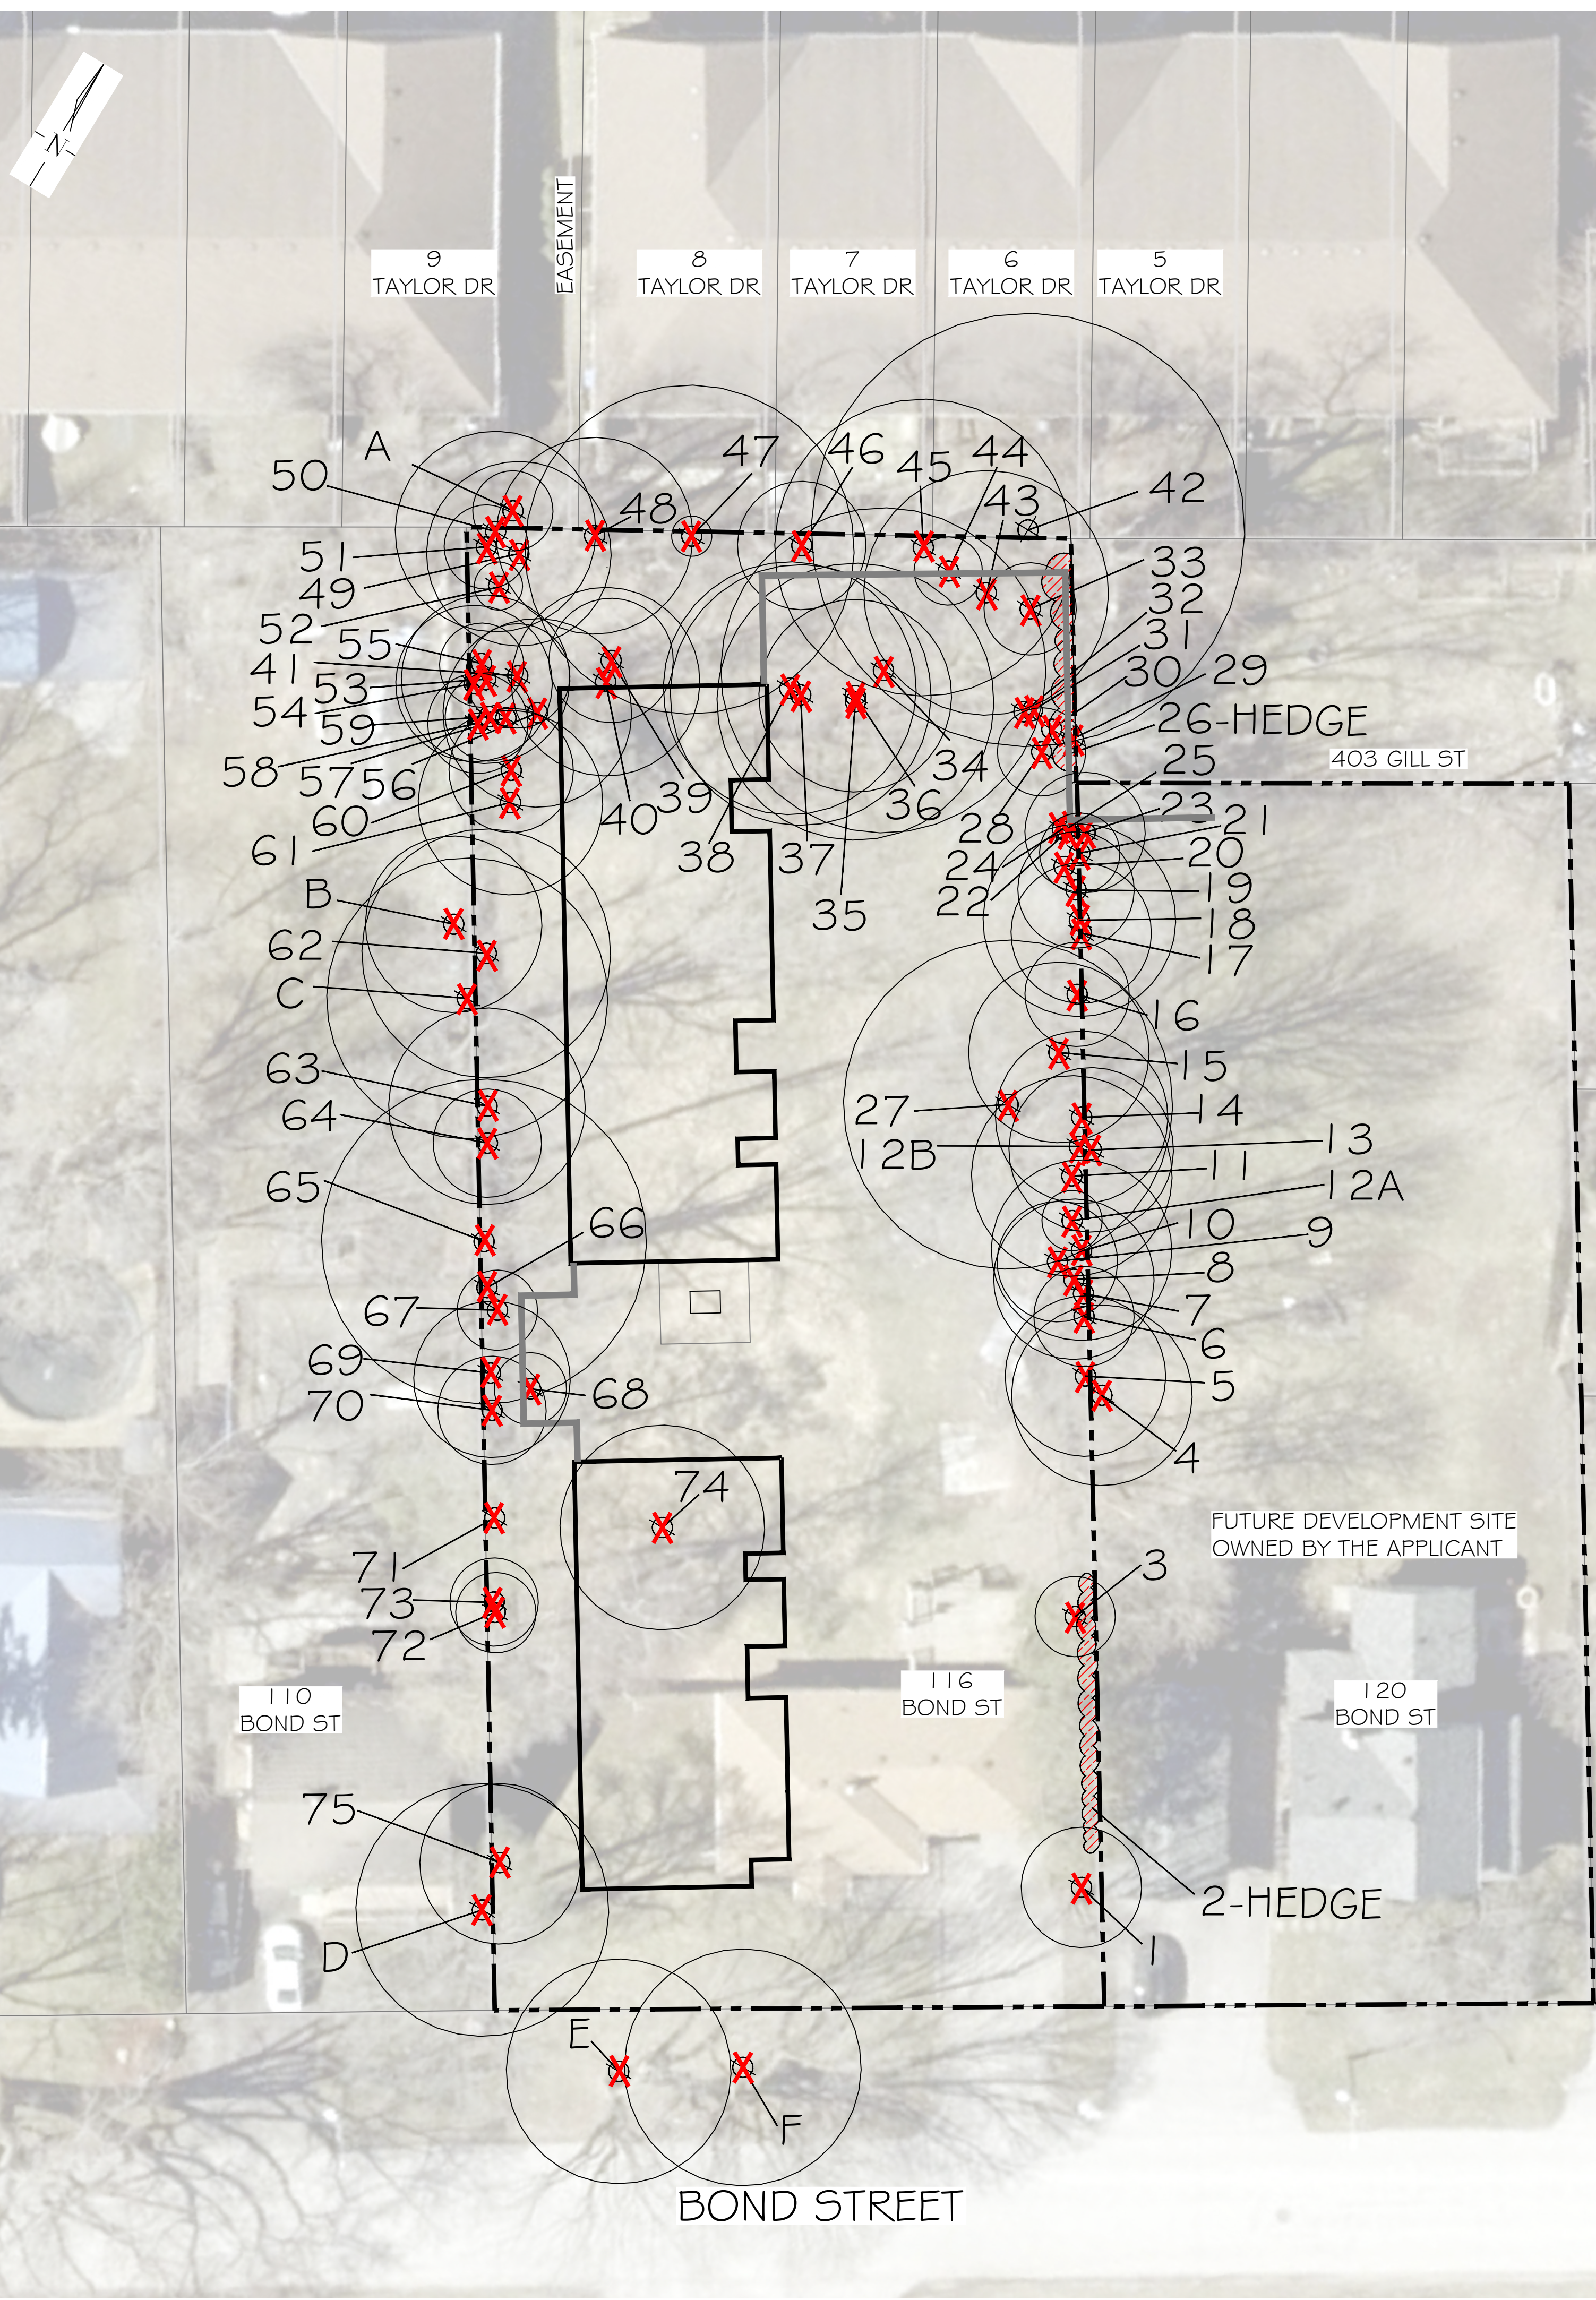
PROJECT NO.: LA 1010-25	SCALE: 1:200
MUNICIPAL FILE NO.:	DATE: October 20, 2025
DRAWN BY: J.M.	CHECKED BY: J.H.
DRAWING No.:	TP-1

TREE INVENTORY (116 Bond Street)									
Key	Location	Latin Name	Common Name	DBH (cm)	Comments	Assessment	Canopy	Preserve /Remove	
1	Onsite Tree	<i>Juglans nigra</i>	Black Walnut	29, 29.5, 32.5	Epicormic branching, pruned multiple leaders included bark, 1 stem cut	3 Fair	3.0	Remove	
2	HEDGE	<i>Thuja occidentalis</i>	Eastern White Cedar	15-25	Multiple stems, branch dieback, snow load damage	2 Marginal	2.0	Remove	
3	Onsite Tree	<i>Fraxinus pennsylvanica</i>	Green Ash	16.5	Offset canopy, epicormic branching, crooked trunk	1 Poor	2.0	Remove	
4	Onsite Tree	<i>Acer negundo</i>	Manitoba Maple	26.5, 32, 30, 14	Multiple trunks included bark, epicormic branching, decay at base	1 Poor	4.5	Remove	
5	Onsite Tree	<i>Acer negundo</i>	Manitoba Maple	17, 27	Fruiting bodies, lean, epicormic branching, included bark	1 Poor	4.0	Remove	
6	Onsite Tree	<i>Juglans nigra</i>	Black Walnut	26	One sided branching to west, roof flare swell	2 Marginal	2.5	Remove

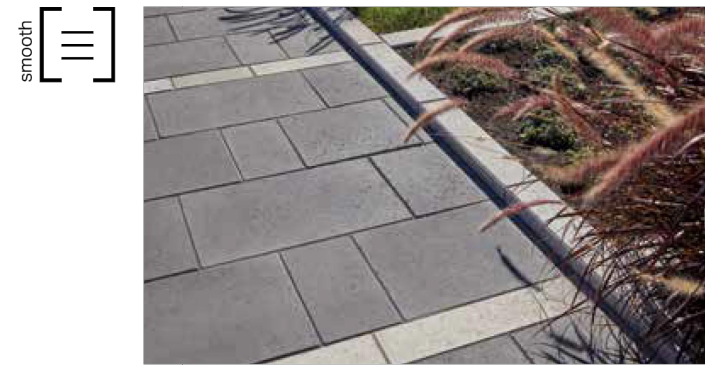
Melville® 80 Paver

- Technique:** 1 bag of sand covers approx. 116 ft²
- Pedestrian:** Designed to withstand pedestrian traffic
- Vehicular:** Designed to withstand car traffic

DIMENSIONS (MM)	DIMENSIONS (IN)	CODES	COLORS	TYPICAL ROW	
A	80 x 190 x 380	3 1/8 x 7 1/2 x 15	1055089	Range Amber Beige		
B	80 x 380 x 380	3 1/8 x 15 x 15	1055097	Range Amber Beige		
C	80 x 380 x 570	3 1/8 x 15 x 22 7/16	1055057	Range Amber Beige		
	Weight/unit (avg.)	27 kg	59 lb	1055446	Range Scandia Grey	
	Unit/surface (avg.)	7.29 unit/m²	0.69 unit/ft²	1055447	Range Margaux Beige	
	Area/layer	1.28 m²	13.66 ft²	1055107	Range Bayona Grey - W	
	Area/cube	8.64 m³	8 Rows	93.28 ft³	STANDARD COLORS	
	Length/row	3.04 m	9.97 in.	ft	1055088	Range Shaded Grey
	Length/cube	24.32 m	79.79 in.	ft	1055058	Range Newport Grey
	Weight/cube	1716 kg	3783 lb		1055113	Range Nervic Grey

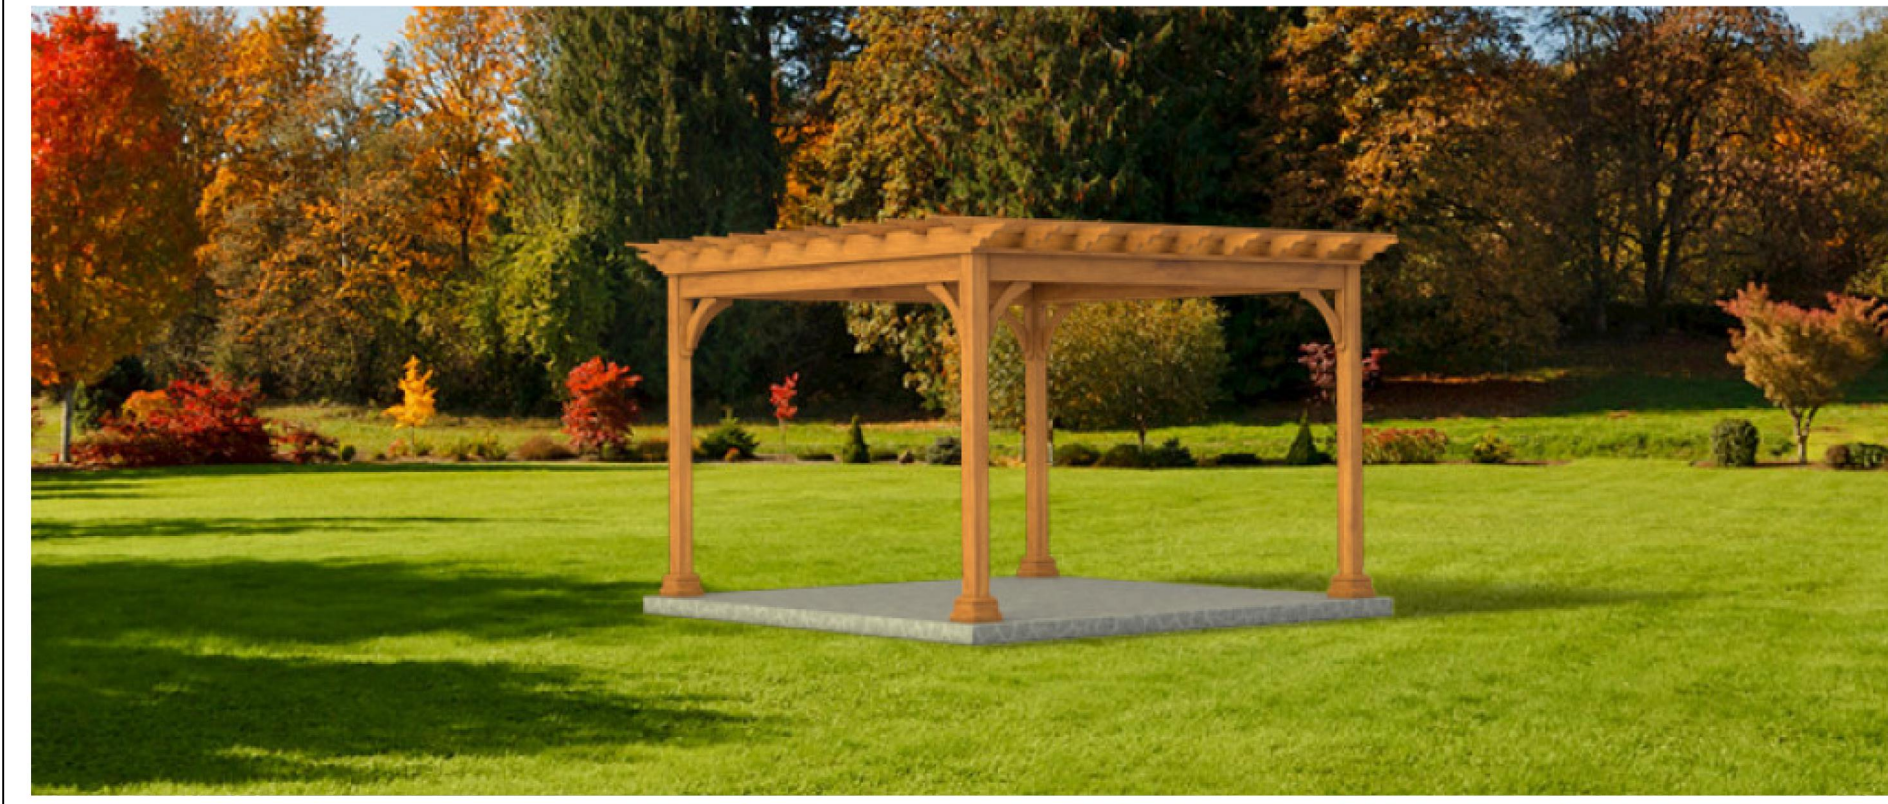
STYLE: Pergola, Wood, Traditional
SIZE: 12x12
COLOR: Stained, Cedar
POSTS: 5x5

EXTRAS:
 Lattice Roof: Yes,
 Electrical Package: No

12' x 12' Wood Pergola with Lattice Roof - Cedar Stained, 5 x 5 Posts
 Supplied by Countryside Gazebos Canada Ltd. or Approved to be equivalent.

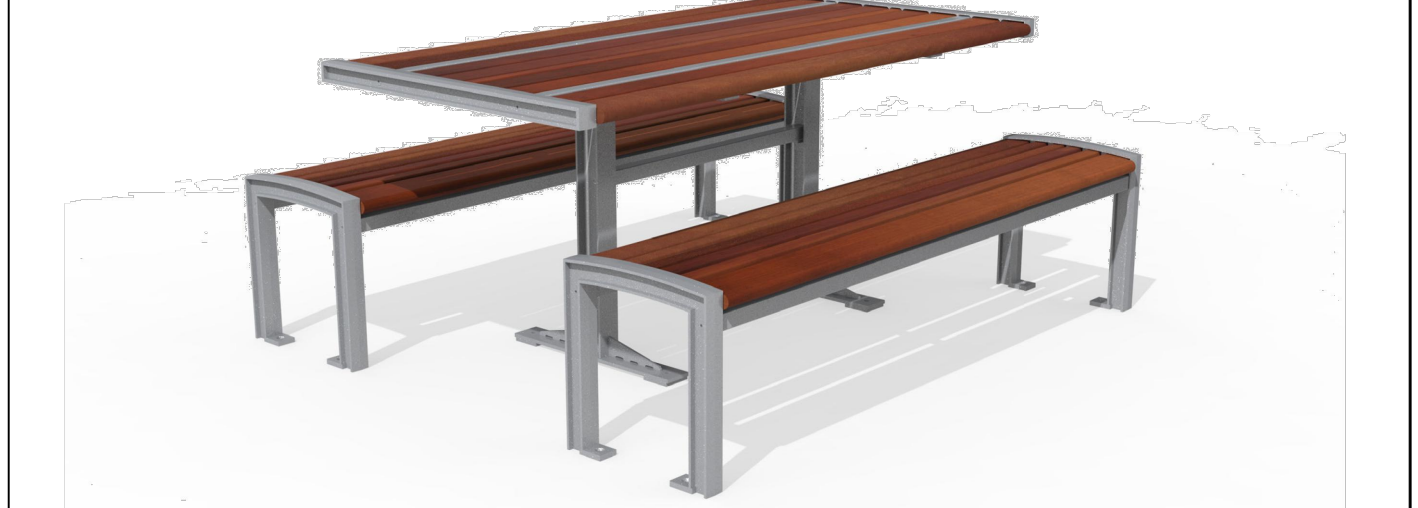
MTB-0720-00002 700 SERIES

MATERIALS: This wheelchair accessible table top and accompanying bench seats (2) are manufactured using lpe wood slats. The table and bench frames are solid cast aluminum, H.S. steel tube and flat bar.
FINISH: All steel components are protected with E-Coat rust proofing. The Maglin Powdercoat System provides a durable finish on all metal surfaces. Wood slats are finished with penetrating sealers.
INSTALLATION: The 700 Series Cluster Seating surface mount tables are delivered pre-assembled. Benches come pre-assembled. Holes are provided in each foot for securing to base.
TO SPECIFY: Select MTB-0720-00002
 Choose:
 - Powdercoat Color

TABLE HEIGHT: 30" (76.2cm)	TOTAL LENGTH: 70" (177.8cm)	TABLE WIDTH: 37" (94.0cm)
----------------------------	-----------------------------	---------------------------
